# HydraTite®

JOINT SEAL

**Market**  
*Water & Utilities*

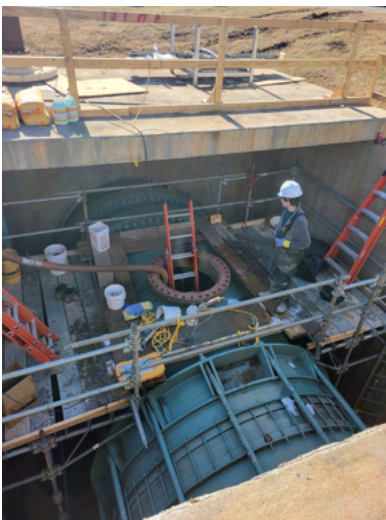
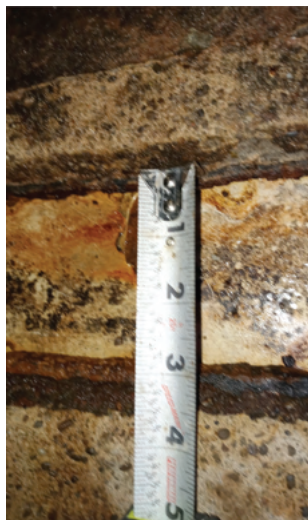
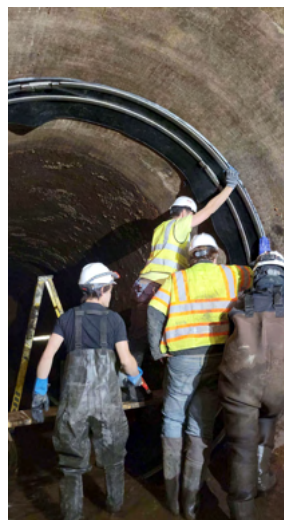
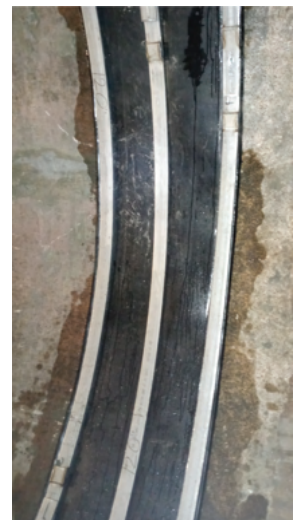
A 120" distribution pipe with five aging pipe joints had become separated at a water pump station. Some joints had separated as much as five (5) inches. The station was concerned that there would be a failure of the joints if the problem was not corrected.

Two of the five pipe joints showed leakage. A solution was needed to eliminate leakage, while not excavating the site. A relatively low-cost solution was proposed to use grout and two of the HydraTite Internal Pipe Joint Seals.

Concrete grout was applied to all five joints. The two joints that were leaking had the HydraTite seal installed. To limit downtime, the scope of the project was scheduled for a five-day shutdown.

The grout and installation of the HydraTite seals were complete over 3 days. Leakage at the pipe joints was eliminated on time and within budget.
