INTERNAL PIPE

HydraTite®

JOINT SEAL

A leak was identified in a 30" pump suction line at a coal power plant in Ohio. A repair method was needed to prevent digging up the building.

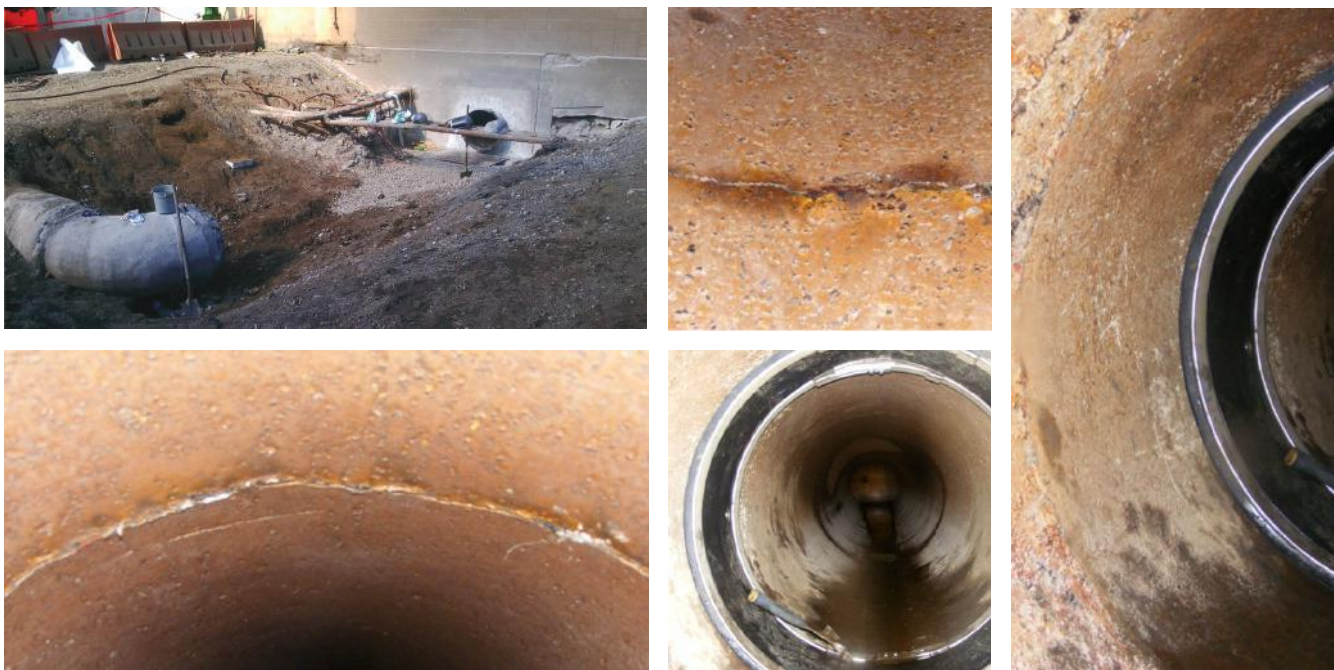
Phase 1

A circumferential crack had formed 16" upstream from the transition joint where the steel connected with the concrete pipe. An extra-wide seal was installed over the leak in only 2 hours.

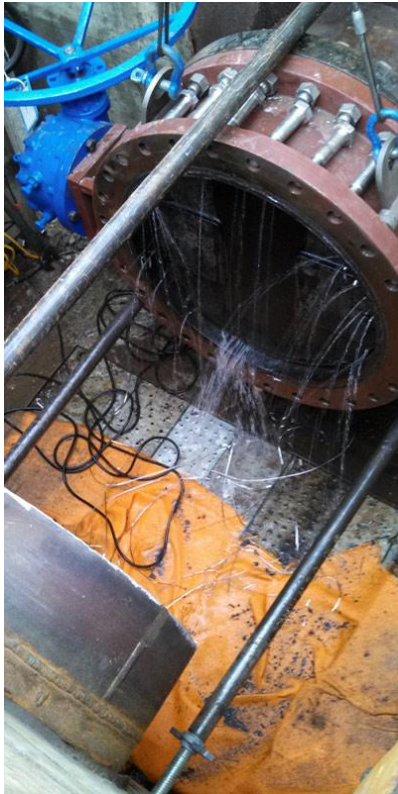
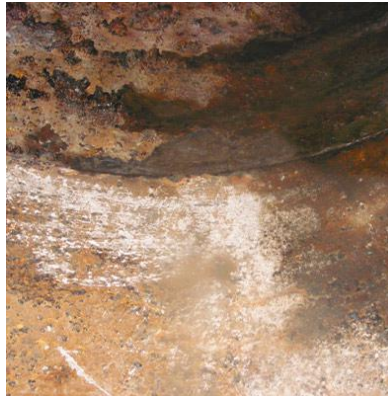
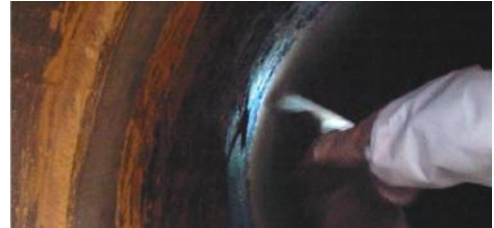
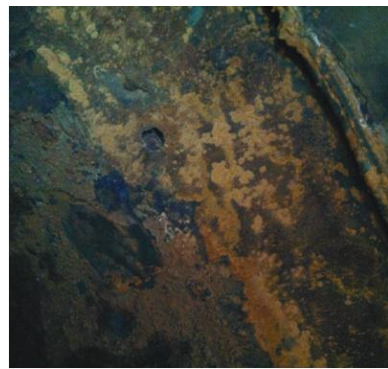
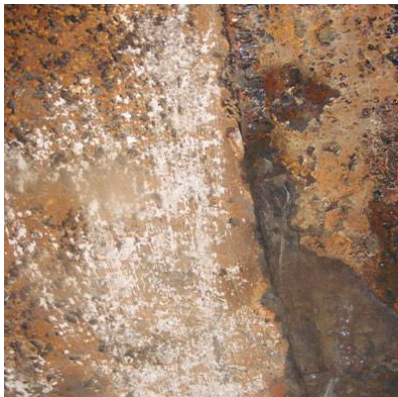
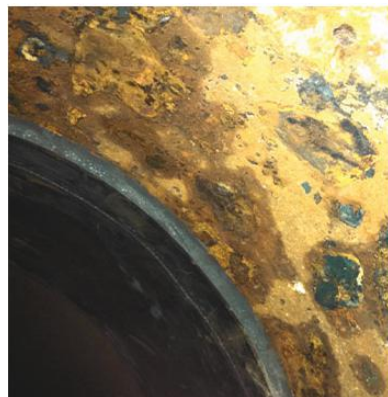
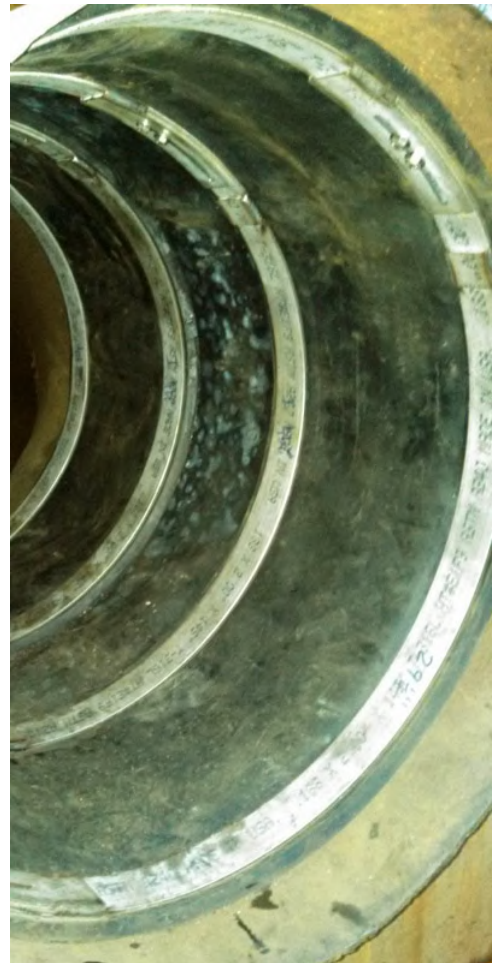
Phase 2

Another section was discovered to be defective near the steel-to-concrete transition. The surface was prepped and the scale was removed to create a smooth surface for installation. Three extra-wide seals were interlocked to form a 35.5" sleeve that covered the defective section and neighboring joint. The installation of the HydraTite sleeve only took 3 hours.
