Market:
DOT

Concrete columns and the crash walls of a bridge had begun to spall, exposing the reinforcing bars, and beginning to raise the concern of the structure's integrity.

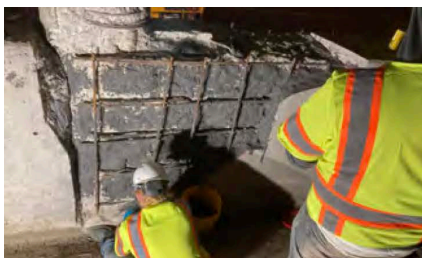
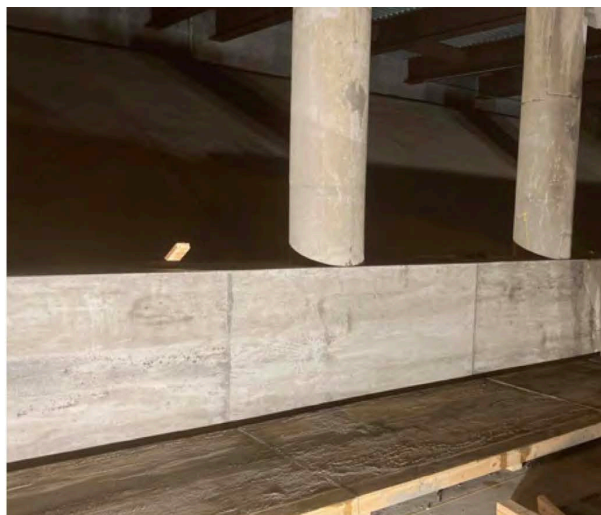
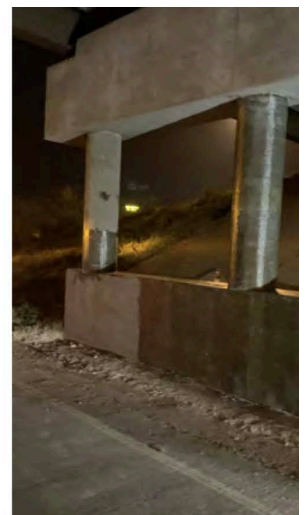
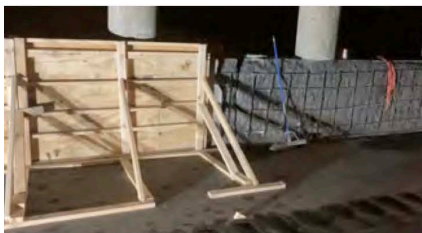
Damaged sections were marked and jackhammers were used to remove the spalling sections. Sections of the crash wall had deteriorated sufficiently to expose the reinforcing bar. Tie wire was used to restore the rebar back into place. The surface was then media-blasted to remove any remaining loose debris. The concrete form was put up and the new concrete was applied. Once the concrete was set, grinders were used to rough up the surface to ensure the carbon fiber wrap would adhere correctly. Next, the carbon fiber wrap was applied. Finally, the fiber wrap was given a topcoat. The total repair resulted in reinforcing five crash walls and 30 columns.

The project plan involved removing loose and spalled concrete sections of both the column and crash wall and replacing the deteriorated areas with new concrete. In addition to the concrete repairs, the columns were wrapped with a carbon fiber composite to provide concrete confinement. This additional step provided a cost-effective and long-term repair, adding extra strength and protection.

Replacing deteriorated concrete and installing carbon fiber wrap confinement provides a time-efficient economical solution compared to replacement while extending the service life of the bridge.
