Market

Water / Utilities

A Colorado water treatment facility identified multiple compromised joints within a steel raw water transmission line, including areas where joints had become offset and separated. Portions of the pipe had previously been lined with both mortar and epoxy, but sections of these liners had deteriorated, further exposing the pipe to damage. The system was actively leaking and at risk of corrosion.

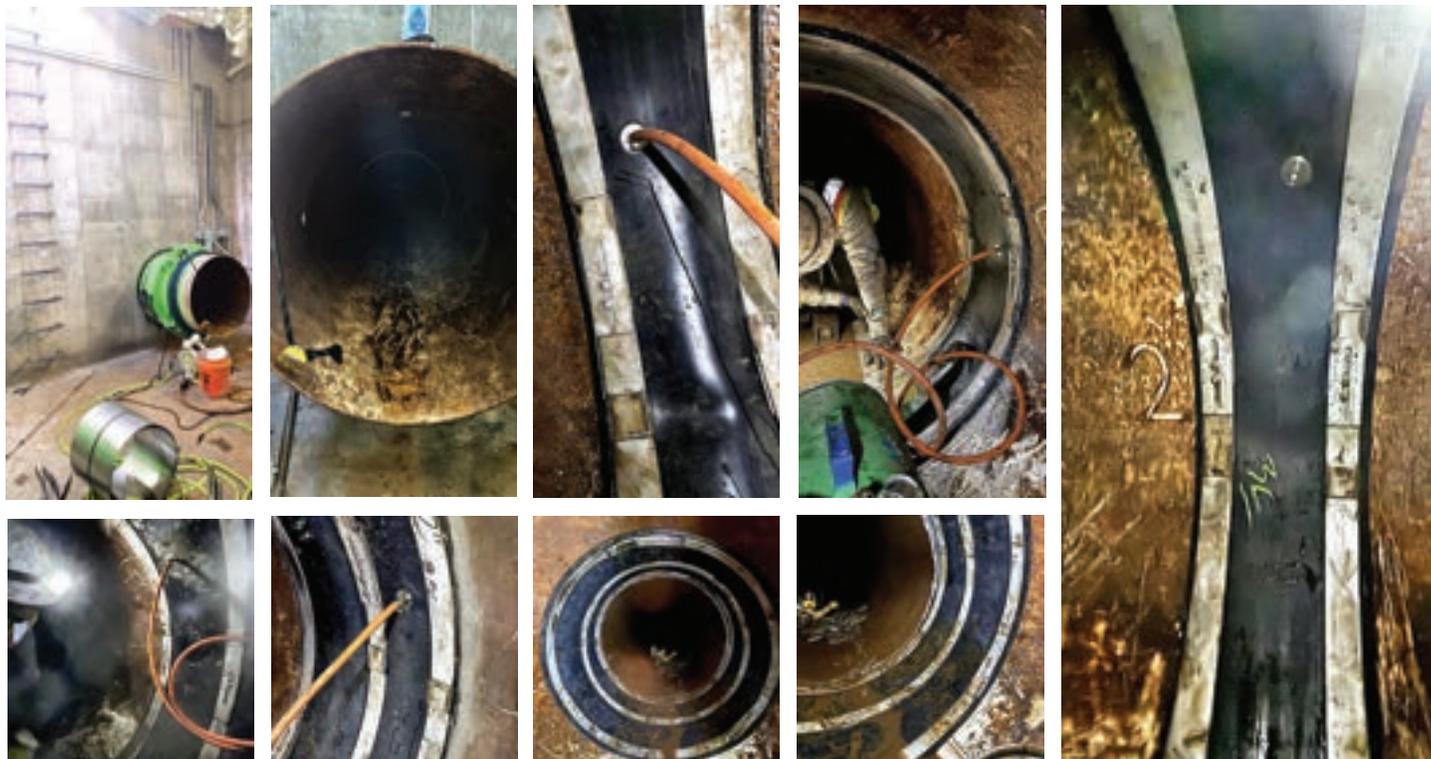
In addition, localized defects were discovered, including a 1-inch active leak and an unused 6-inch fire hydrant lateral that required sealing. The facility required a solution that could restore system integrity within a tight timeline of less than one month, while working within confined access points and without extensive system disruption.

A total of nine HydraTite® seals were installed over two days, including three standard-wide, three extra-wide, and three double-wide seals. Most installations occurred within a 36-inch steel pipe, with one seal installed in a 42-inch line. The 42-inch joint required additional preparation, as an existing liner had to be chipped away to allow proper seal seating.

Two locations required additional structural support using backing plates. At one joint, an unused 6-inch hydrant lateral was filled with mortar; a backing plate was positioned over this area prior to sealing. At another location, a 1-inch active leak was identified and sealed using a backing plate beneath a double-wide HydraTite® seal. The seals were each air tested to ensure a proper installation.

Throughout the installation, areas of compromised liner were addressed by applying epoxy coating to exposed sections of the pipe, helping to mitigate corrosion risks and ensure long-term performance.
