*Water / Utilities*

A Texas raw water system continued to experience leakage within a 39-inch steel pipeline after two HydraTite® Internal Pipe Joint Seals had recently been installed nearby. Because the renewed leakage appeared close to one of the previous repairs, there was initial concern that an existing seal may have become compromised.

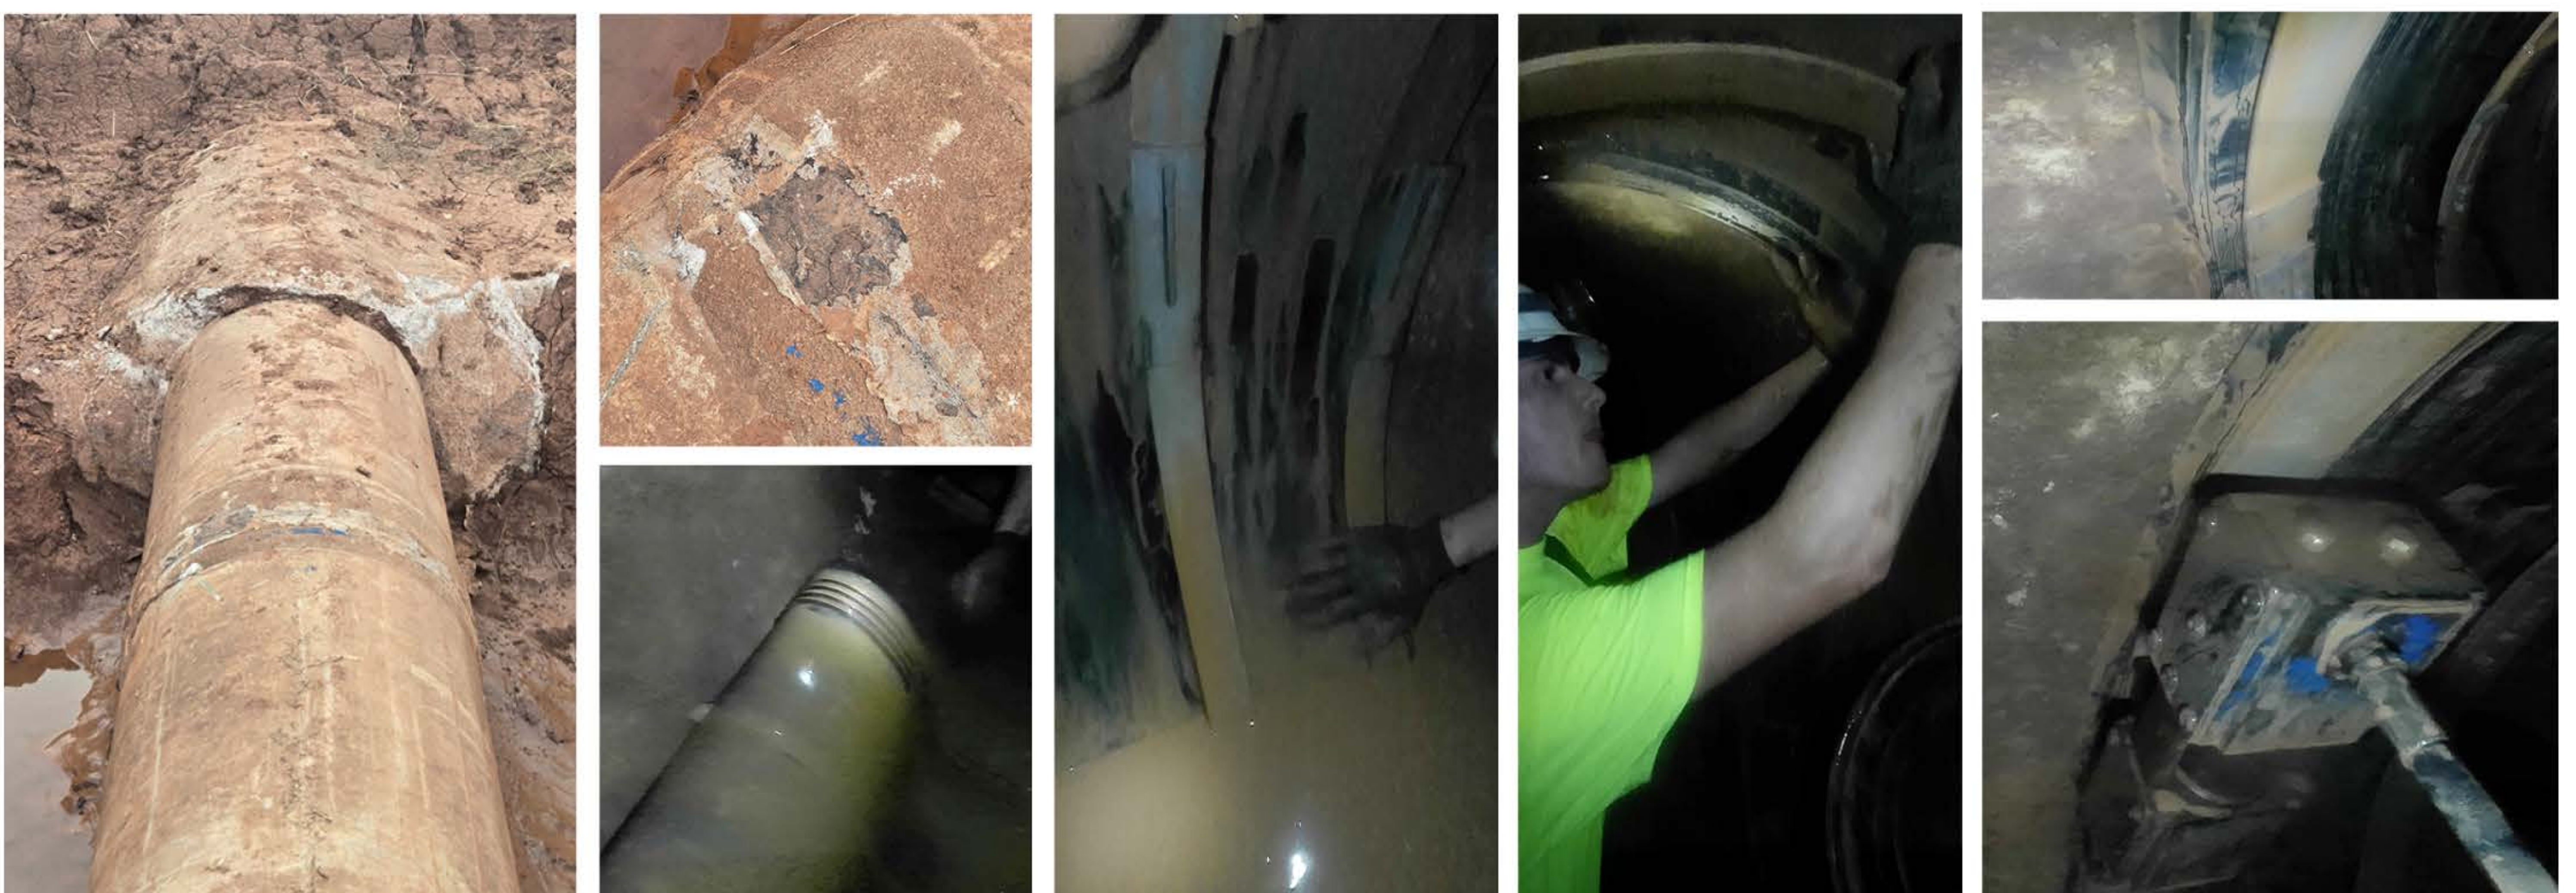
Prior to HydraTech's field crew arriving, at a separate exterior repair location, HydraWrap® materials had been applied by the owner's project. Their team had quickly learned the application process and applied four layers of 12-inch-wide fiber fabric over the repair area. The HydraWrap® installation was completed in approximately one working day and provided structural support for the low-pressure pipeline.

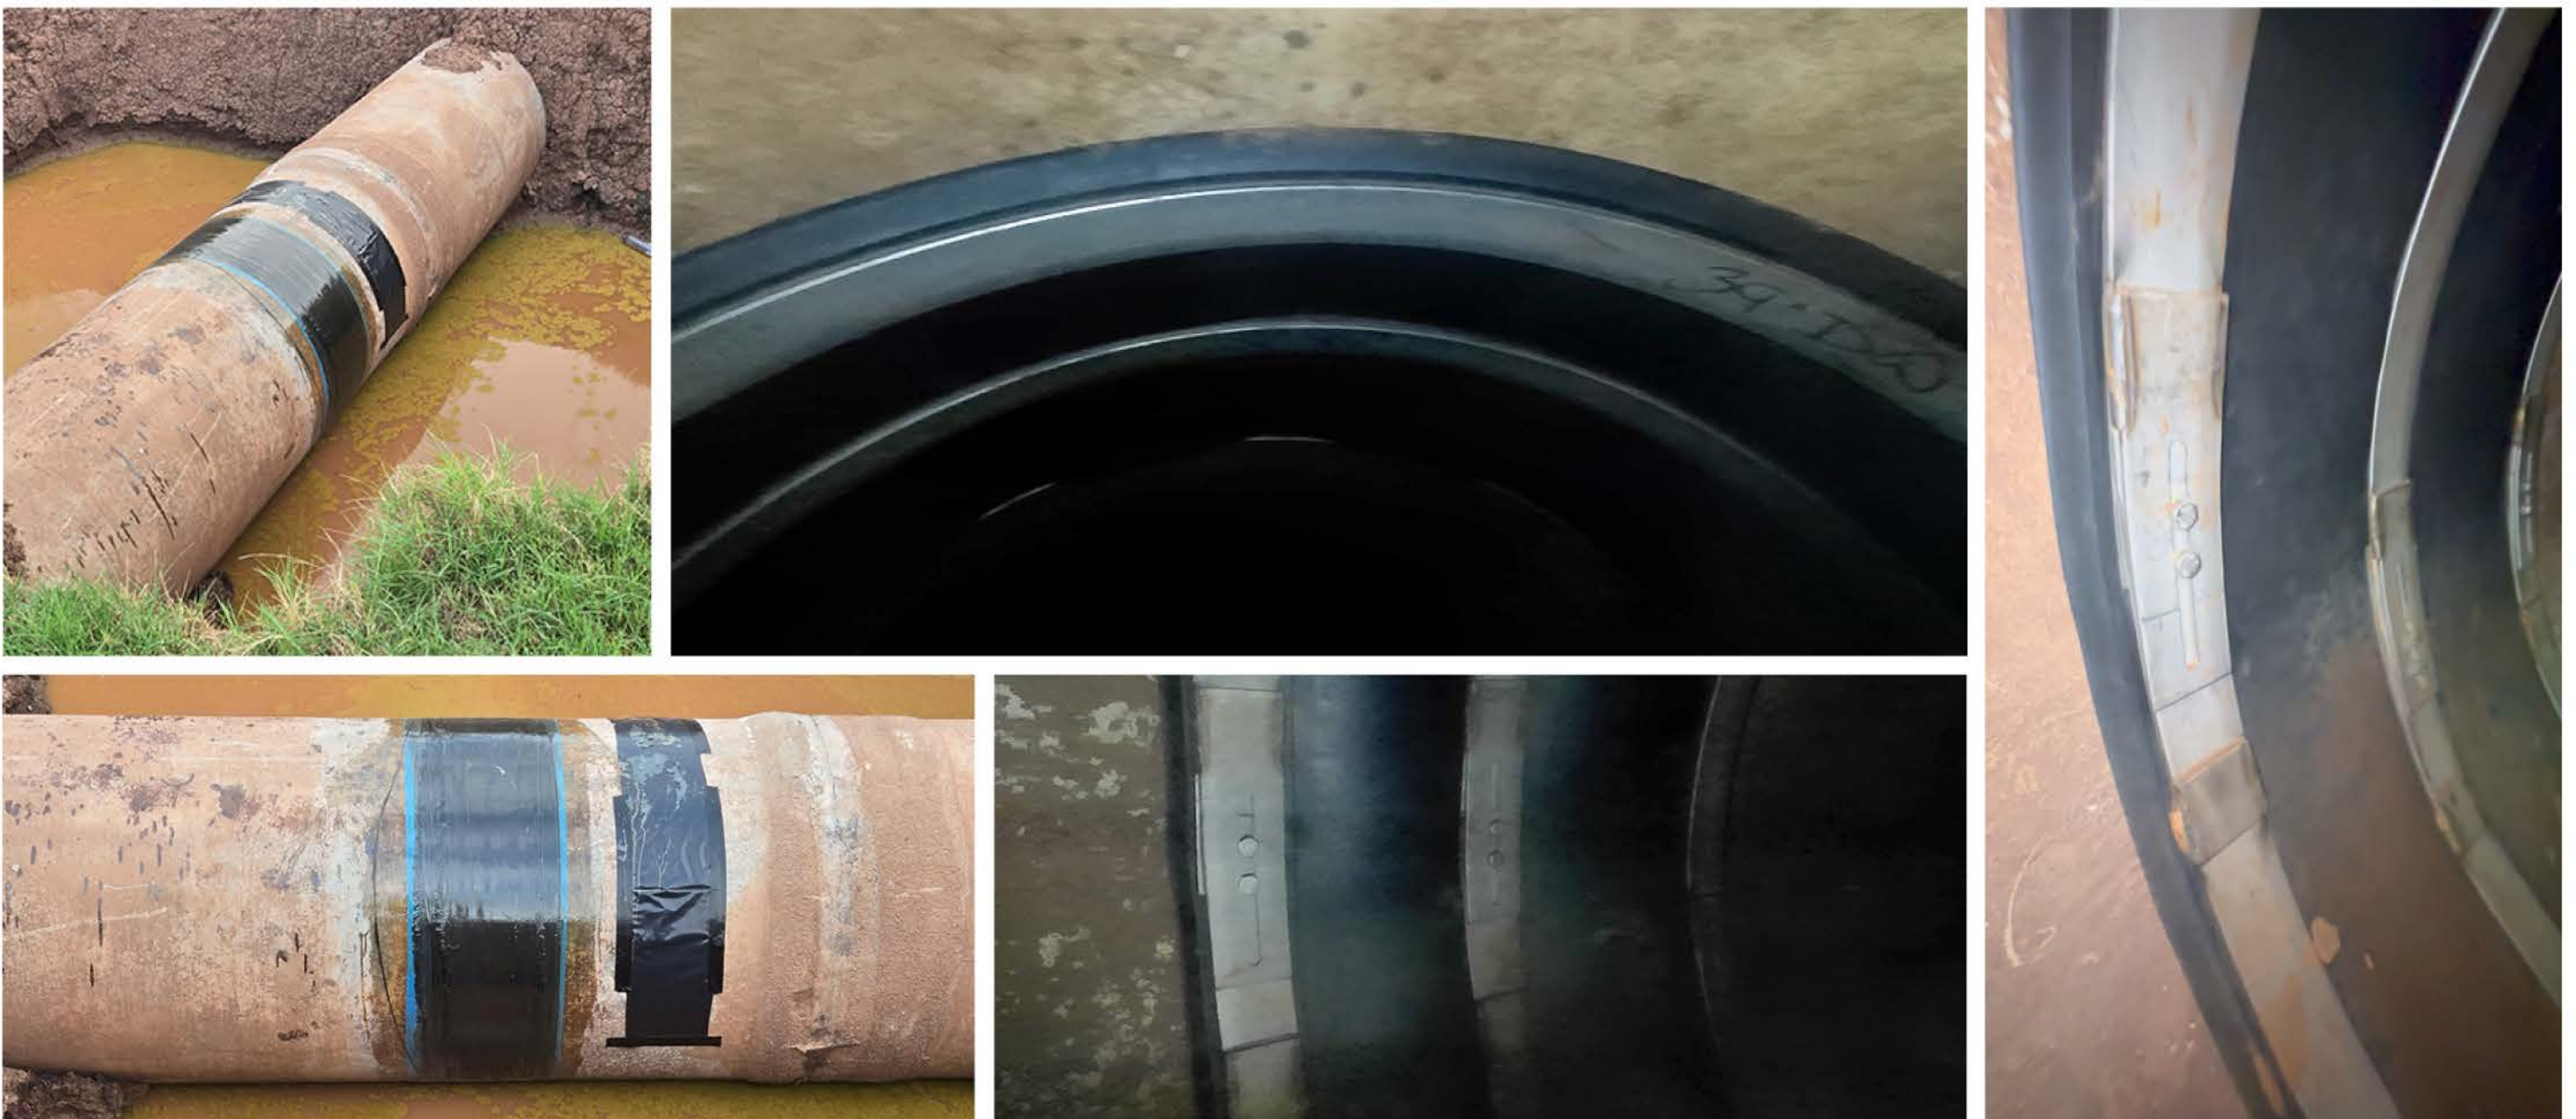
The double-wide HydraTite® seal successfully covered the hairline fracture and restored the integrity of the raw water line. The project also confirmed that the seals installed during the previous mobilization remained watertight and were performing as intended.
