Power & Utilities

## Challenge

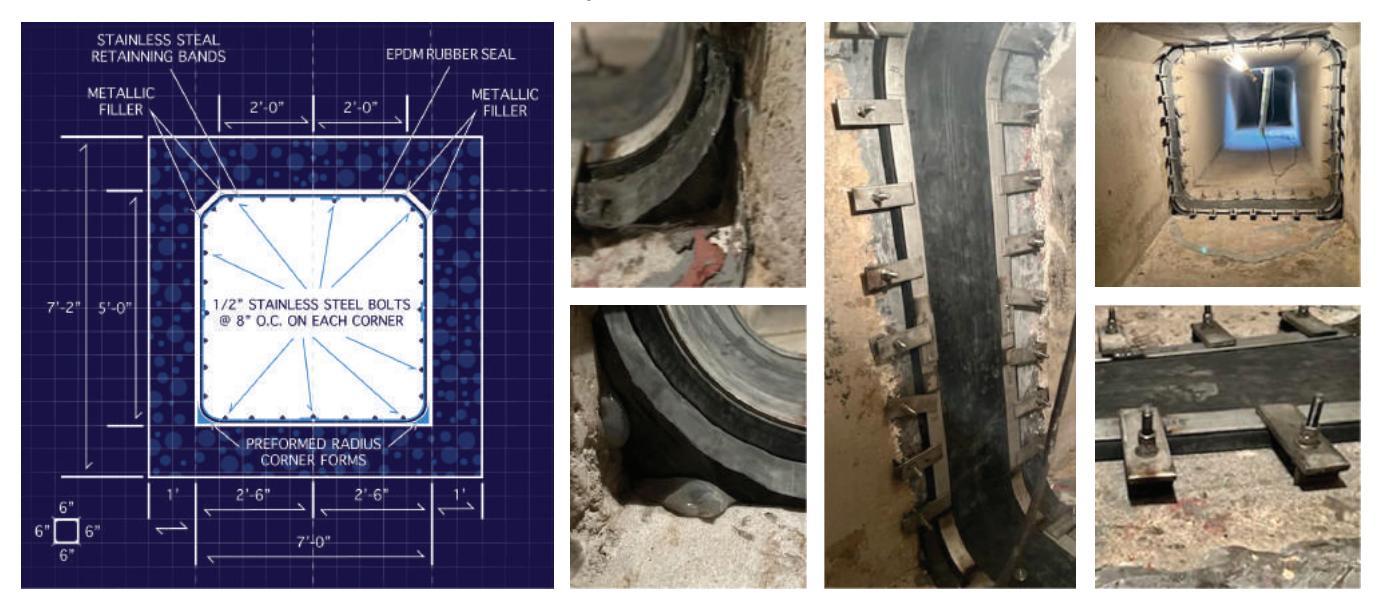
Power plant personnel had determined that a flume had begun to leak. The water stop in the joint had failed in the flume that transferred water from the plant's condenser to the cooling tower. Previous repair attempts failed to eliminate the leak that was allowing exfiltration to the ground surface. The reinforced concrete flume's interior dimensions were 5' by 5' with the top corners of the flume having a 45-degree chamfer which reduced the top to 4'. The failing joint had approximately 4' of overburden soil.

The engineer searched for a repair that would eliminate the leak and HydraTite's customizability made it the preferred solution. HydraTite could accommodate the irregular shape of the flume when installed with metallic filler in the top corners, preformed radius corners in the 90-degree bottom corners, and anchor clamps.

The power plant personnel completed the surface preparation and installation of the extra-wide HydraTite seal during the scheduled outage.

HydraTite proved to be an effective solution that eliminated the leak quickly and economically. This customized solution will protect this flume's joint for decades.
