Market: Power

## Challenge:

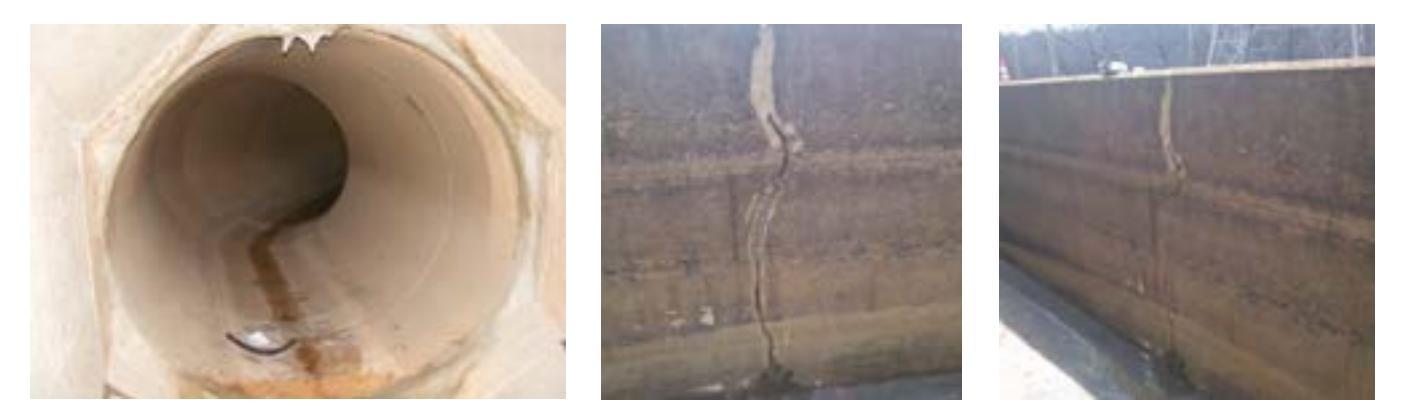
A power plant in Kentucky had cracks forming on two aging concrete structures which were the cause of leaking. The first was a cooling tower basin's wall. The wall required two points of repair. The other was a cooling water tunnel, specifically at a transition where a 70" I.D. steel pipe connected to a rectangular concrete tunnel.

Hydraulic cement would be used to fill the cracks and HydraWrap was to be applied over the cement for protection and strength. Finally, the repairs to the basin walls would be coated in a fast-drying urethane. The power plant chose HydraWrap as its installation is time-efficient.
