HydraTite® Internal Joint Seal

Power

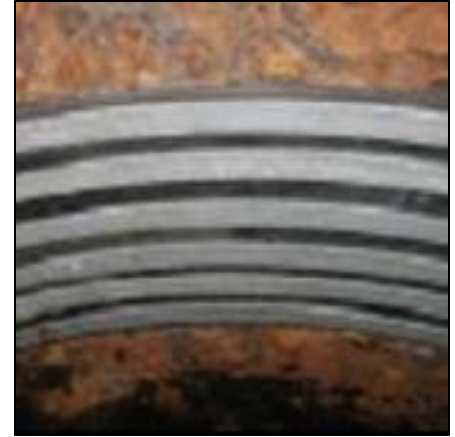
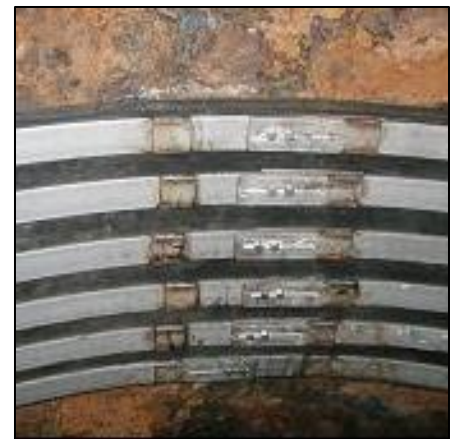
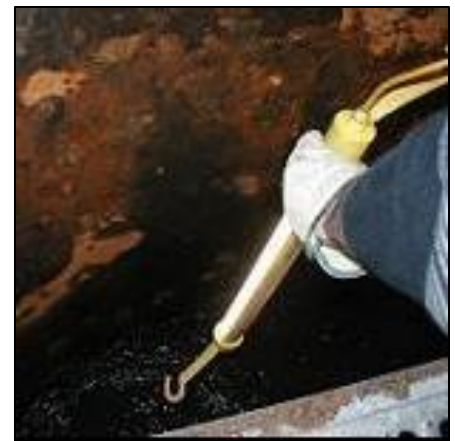
The circulating water box system requires a vacuum on the system to allow proper circulating water level in the water box to provide cooling through all tubes. This operating performance was degraded due to through wall leaks in the discharge piping that allowed atmospheric pressure to reduce vacuum levels and thus reduce cooling capacity of the condenser and overall electrical generation.

The solution proposed utilized the HydraTite seal with six three-piece stainless steel 316 steel bands, a double wide HydraTite seal and a 16 gauge stainless steel backing plate.

The crew and all materials entered through an existing manhole and were able to complete the system installation within the work window provided by the station.

At the completion of the project the system performance was brought back to as built specifications with the nuclear plant able to operate at better efficiency and thus increase electric generating output.
