INTERNAL PIPE

HydraTite

JOINT SEAL

Market
Sanitation

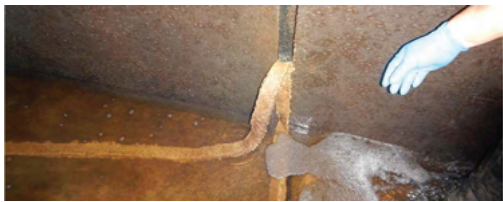
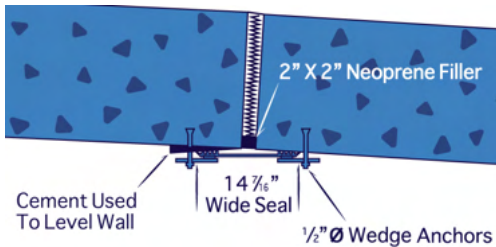
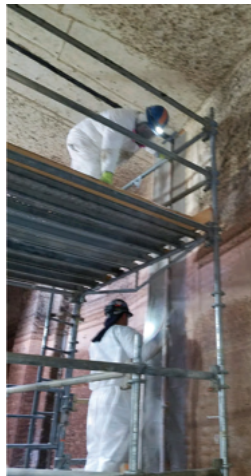
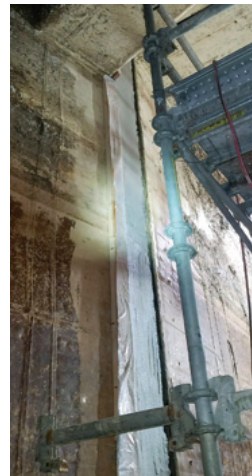
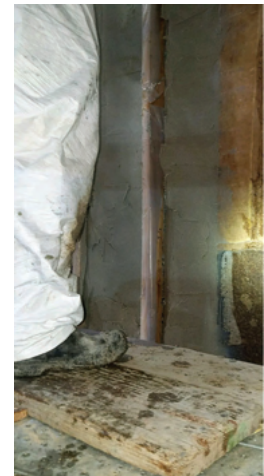
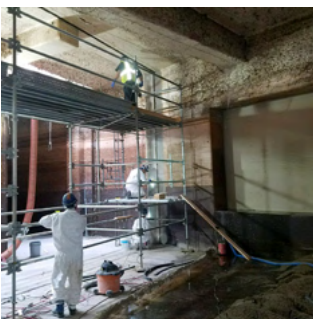
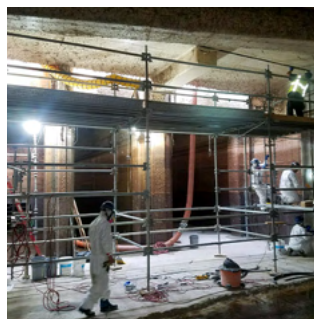
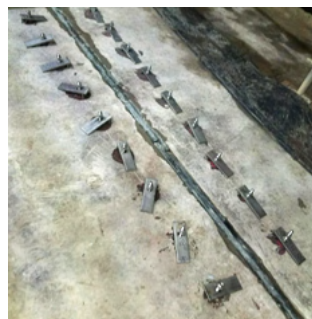
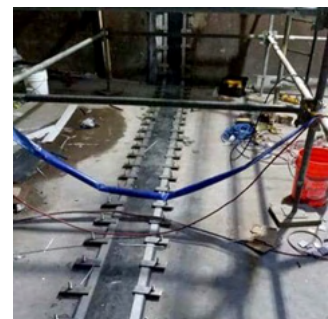
Filler had begun falling out of the expansion joint that was part of an ocean outfall system. This joint in the west junction structure needed to be rehabilitated with a long-term solution.

An 18' by 30' extra-wide box HydraTite was manufactured for the job. Anchor plates, EPDM corner forms, wedge anchors, concrete, and a 2" by 2" neoprene pad would be used together with the HydraTite seal to ensure the joint was fully restored.

HydraTech was to furnish the seal and supervise the installation. The crew used the concrete to level out the wall's surface to allow for the proper installation of the HydraTite Seal. The neoprene pad was inserted into the joint and the anchor plates and corner forms were put in place. Finally, the seal was installed over the joint.

The HydraTite's customizable nature made it the perfect solution for this massive expansion joint. The repair was on schedule, providing a permanent repair that the previous filler could not.
