INTERNAL PIPE

**HydraTite**  
JOINT SEAL

*Municipal – Water Utility*

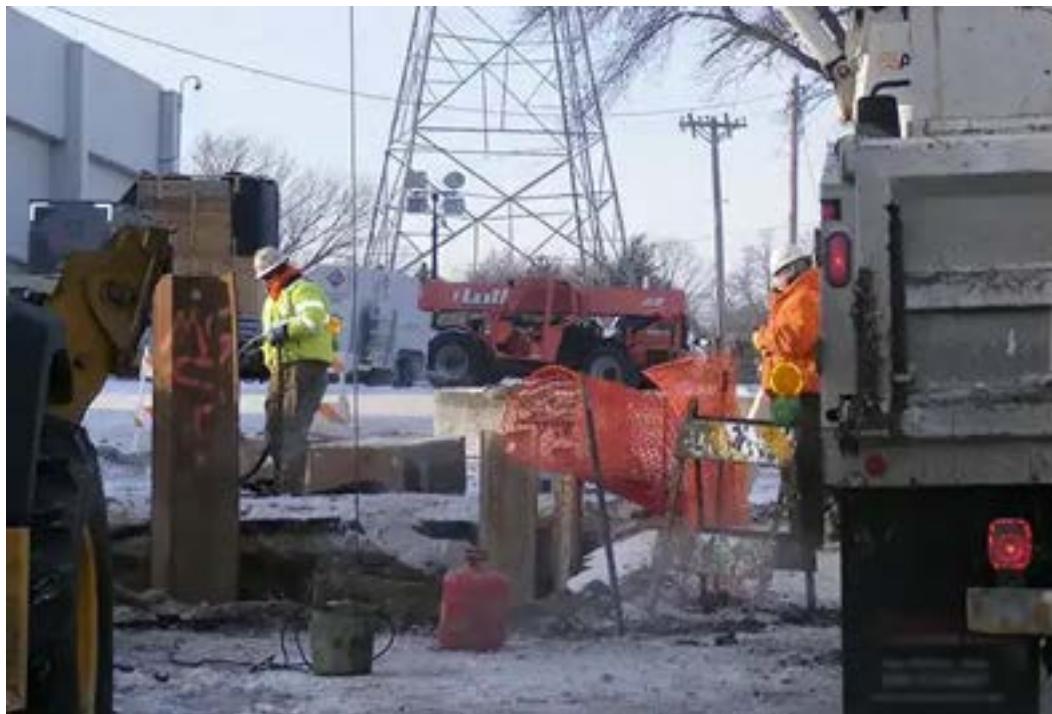
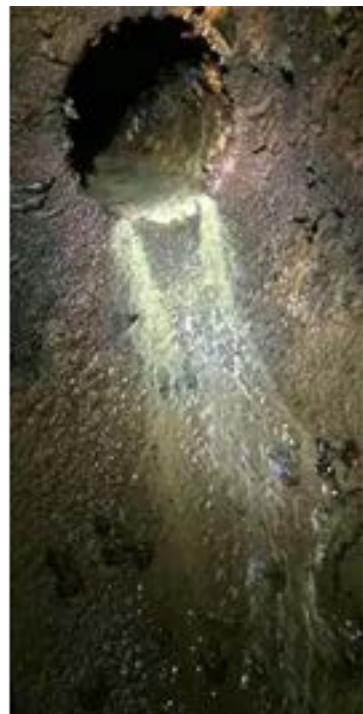
HydraTech offered a trenchless repair approach using the HydraTite® Internal Pipe Joint Seal system, designed to eliminate leakage and restore structural integrity without the need for excavation. The solution utilized standard-wide EPDM HydraTite® seals, with dual 304 stainless steel retaining bands for durability. For select 48-inch joints with Dresser couplings, stainless steel backing plates were incorporated to provide additional support. Each seal was equipped with a test valve, allowing for rigorous leakage testing upon installation to ensure a watertight seal, meeting the high standards required for the critical water infrastructure.

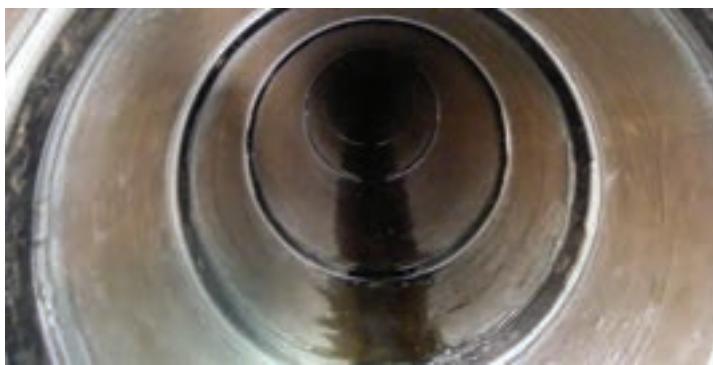
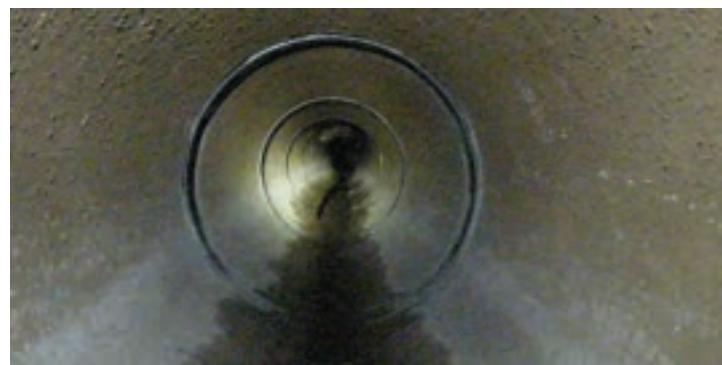
A small dedicated crew mobilized, equipped with confined-space entry gear, air monitoring systems, and specialized installation tools. Over the course of about 35 days, the team installed approximately 200 HydraTite® seals across 24-inch and 48-inch water mains. At the water treatment Plant, 96 joints on 48-inch mains were rehabilitated, while 85 to 88 joints on 24-inch mains were addressed along avenue. Where the interior surface of the pipe showed deterioration, technicians applied hydraulic cement to create a smooth sealing surface for the seal. To protect the flow path and reduce the seal's profile, concrete was applied to the edge of each seal in the 24-inch pipe. This created a smooth transition over each seal. The project adhered strictly to confined space entry protocols, traffic control measures, and project-specific safety analyses, ensuring safe and efficient execution without disrupting the surrounding community.
