HydraTite® Internal Joint Seal

Water / Utilities

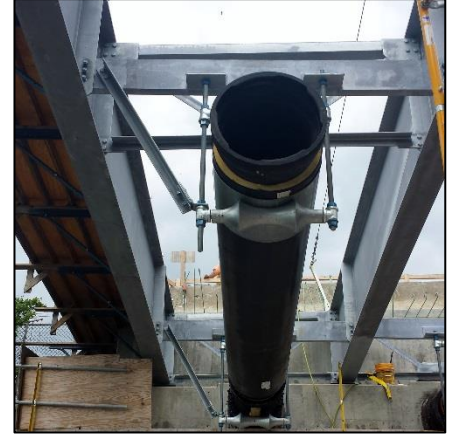
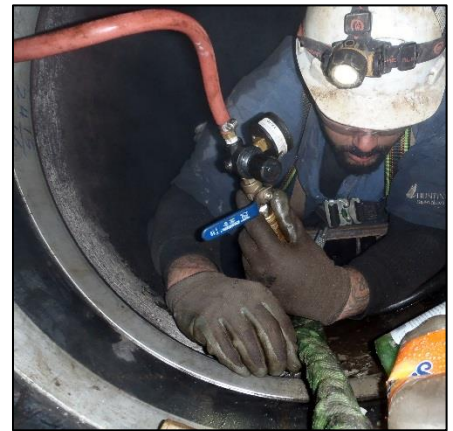
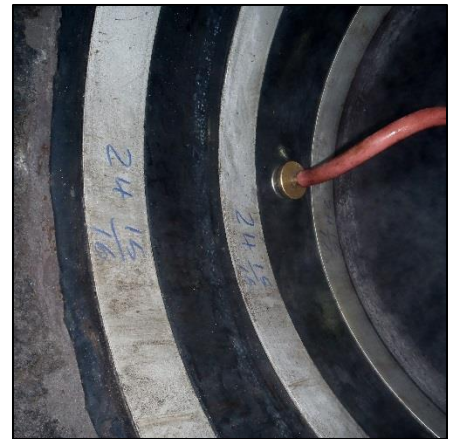
The mortar was removed prior to installing HydraTite. Nine joints were then repaired, at times separated by over 200 feet. Sections of pipe were removed to provide access from suspended scaffolding. The pipe was then reassembled, and the pressure test was successful. HydraTite stopped the leaks for less than 5% of what it would have cost to replace the piping.
