HydraTite® Internal Joint Seal

The 60" diameter HDPE storm water culvert had infiltration issues of contaminated ground water entering the pipe through the pipe joints. This infiltration was causing an environmental issue with contaminated water draining to the river. Several sections of the 60" diameter HDPE piping system had become deformed due to soil loading. This resulted in joint displacement along with varying degree of pipe ovality and pipe joints disconnecting. Sealing the pipe joints would require a method that could accommodate the distortion of the pipe and remain flexible for further deformation or movement in the pipe.

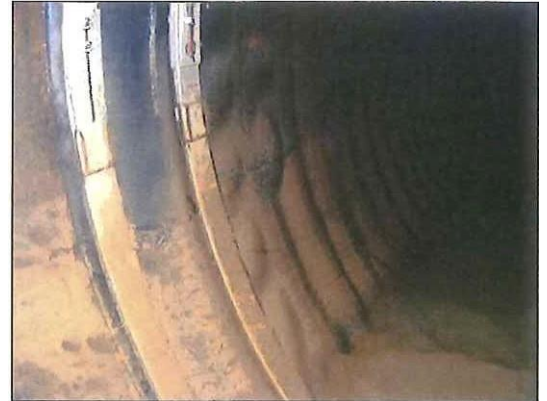
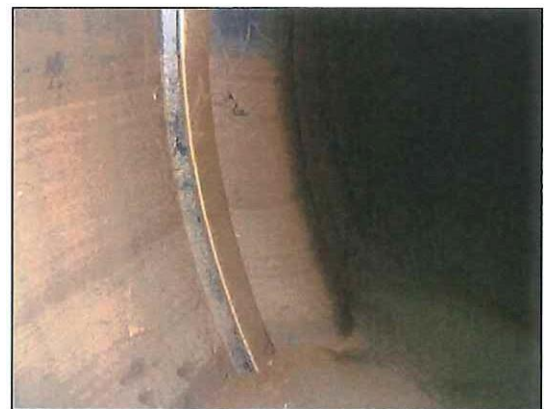
The goal was to eliminate groundwater infiltration with the HydraTite internal joint seal installed at every pipe joint. The versatility of the HydraTite seal was able to cover the pipe ovality while enabling a secure seal to the pipe joints. In three days - sixteen joints were completely sealed and repaired. A post installation analysis of the groundwater had revealed there were no more containments in the pipe. The project was completed quickly and correctly eliminating environmental hazards utilizing the HydraTite Seal.
