HydraTite® Internal Joint Seal

The challenge was to stop infiltration at the pipe joints in a 27-in storm drain.

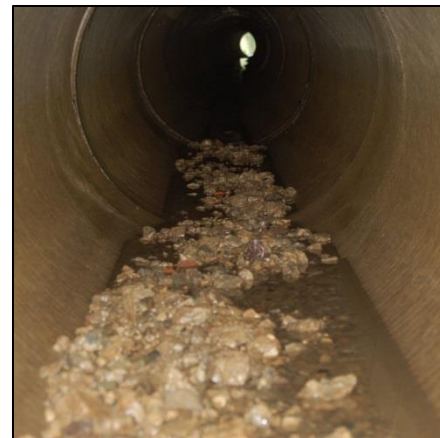
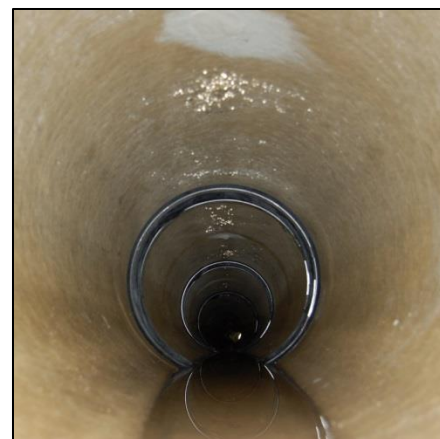
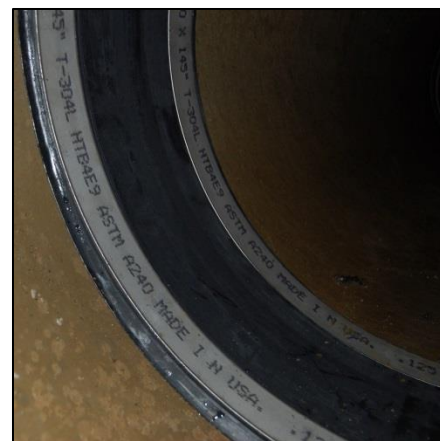
Prior to installation, HydraTech removed the debris, earth and soil from the defective area of the storm drain. The restoration of the pipe included ten 27-in standard wide HydraTite seals. The installation spanned two days.

HydraTite 27-in standard wide EPDM rubber seals with two one-piece 304SS retaining bands were proposed as a solution.

The HydraTite Internal Joint Seal was selected as the long-term solution to eliminate infiltration and prevent ground settling.
