HydraWrap® (Fiber Reinforced Polymer)

The challenge was to repair deteriorated timber support post for several pavilions in lieu of replacing the entire support column.

HYDRAWRAP
STRUCTURAL COMPOSITE REPAIR SYSTEM

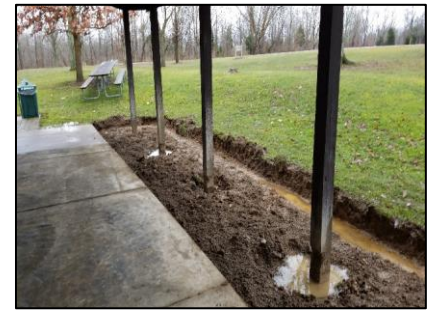
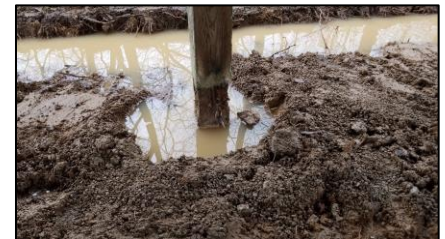
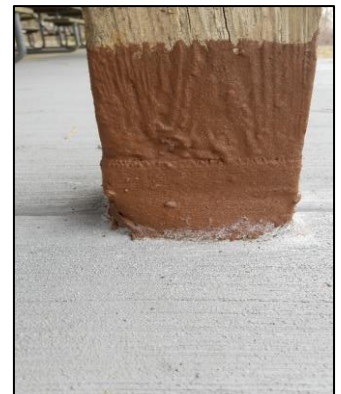
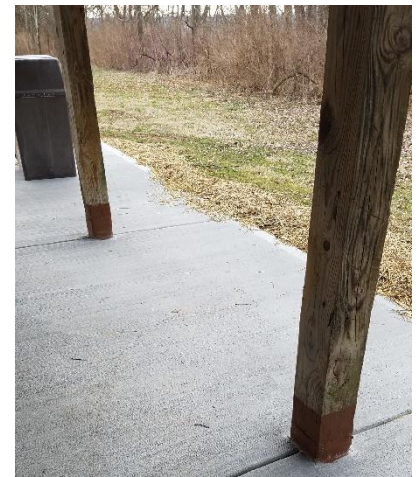
Client was seeking alternate solution to repairing timber support post for park shelters. The support post had deteriorated at the soil-to-air interface - where the support post had been embedded in the concrete slab of the pavilion at the time of construction. The remainder of the timber support post above the concrete slab was in good condition.

To avoid replacing all of the support post, the client utilized the HydraWrap carbon fiber system to restore the deteriorated sections of the timber post at and below the concrete slab grade. The concrete slab, which was included in the scope to be replaced, was removed to expose the embedded timber post. Those post which revealed deterioration and loss of cross section were selected for repair using the HydraWrap system. The HydraWrap system was used to restore the profile of the 6" X 6" timber post and provide a reinforced protective repair to prevent future deterioration.
