Marine HydraWrap® (Fiber Reinforced Polymer)

The challenge was to repair leaks in the cooling water supply pipe.

The solution utilized the Marine HydraWrap Structural Composite Repair System.

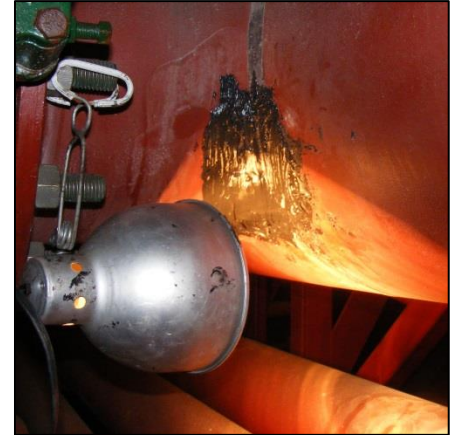
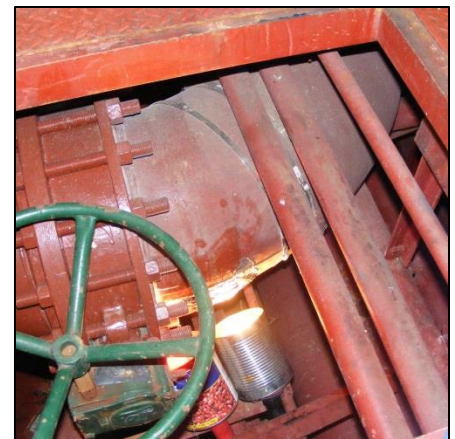
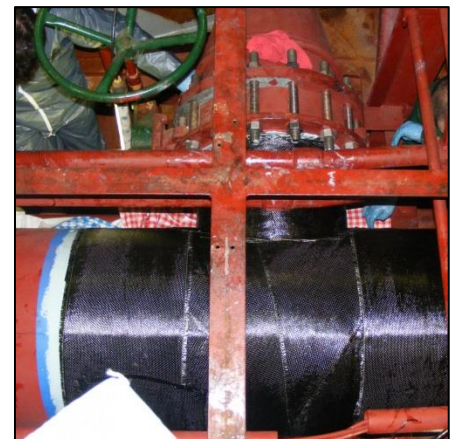
The cooling water system on a vessel experienced leaks and deterioration of the pipe wall. These leaks and deterioration were noticed primarily in the pipe fittings located immediately downstream of the supply pumps.

HydraTech Engineered Products, LLC provided supervision and training services and the vessel's personnel completed the repairs on one 24-in x 18-in tee and one 18-in elbow in one working day.

Temporary patches and repair bands were implemented in the past to reduce the leaking. Still searching for a better repair, the client was introduced to HydraTech's ABS Design Approved Marine HydraWrap, and they requested the repairs be made to several areas of the system where leaks had developed. The areas of the CuNiFe piping were prepared and cleaned using hand and power tools to provide a clean surface and remove any foreign material. The HydraWrap carbon fiber system was then applied.
