An inspection of the Markland bridge revealed deteriorated concrete, exposed rebar, and areas needing repair. Traffic crossing the bridge complicated repairing the spalling concrete. A solution was required that provided a long-term repair while maintaining traffic flow patterns.

HydraTech Engineered Products, LLC

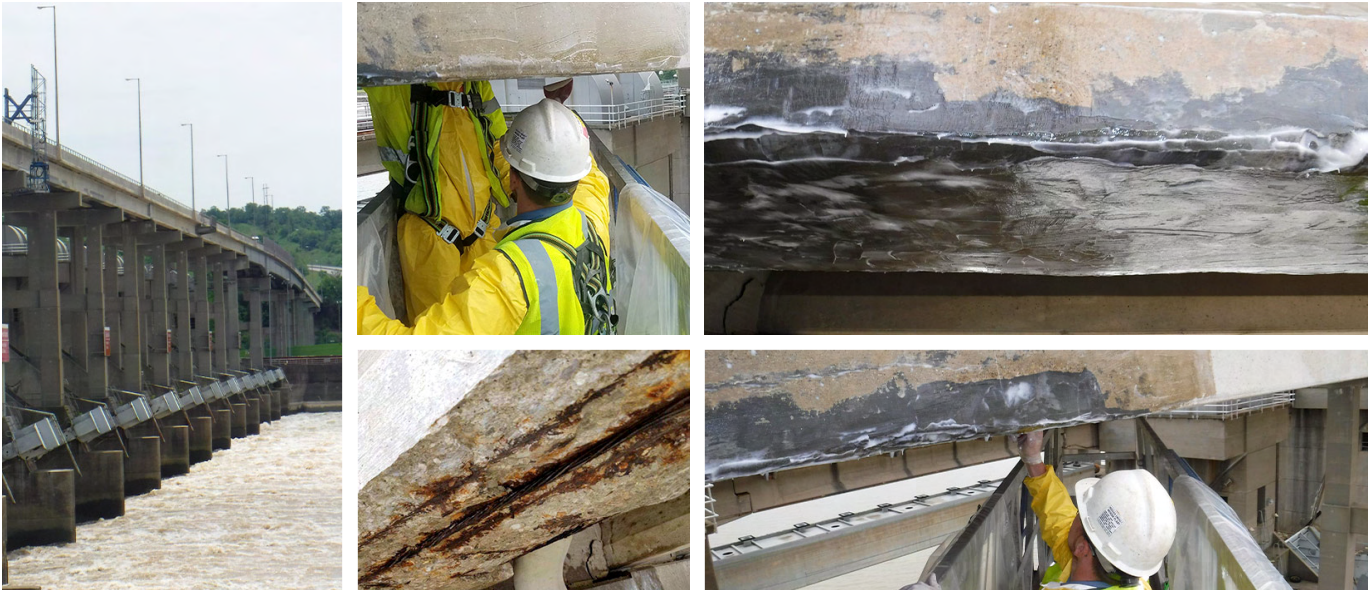
Concrete mortar mix and fiberglass-reinforced plastic (FRP) were chosen to repair and reinforce the aging concrete.

Scope
