INTERNAL PIPE

# HydraTite®

JOINT SEAL

Market  
*DOT*

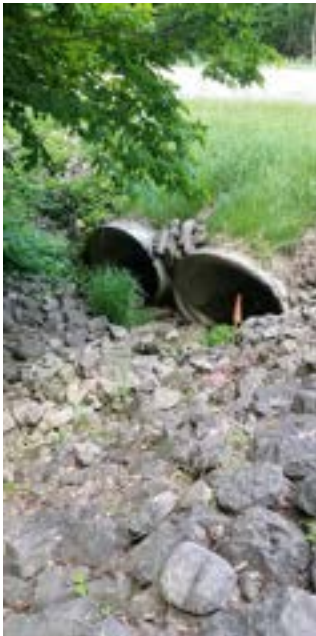
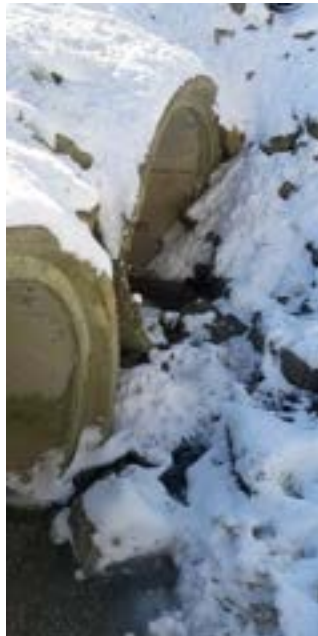
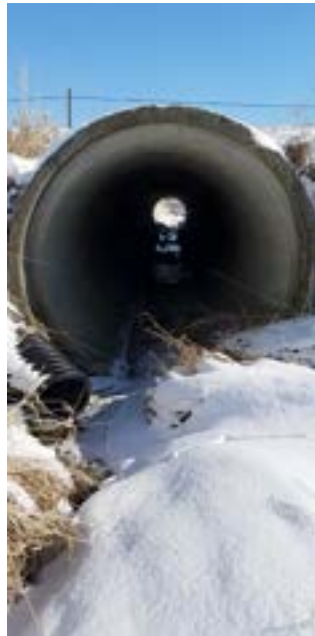
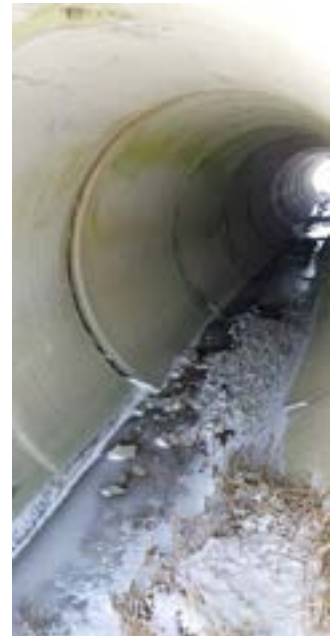
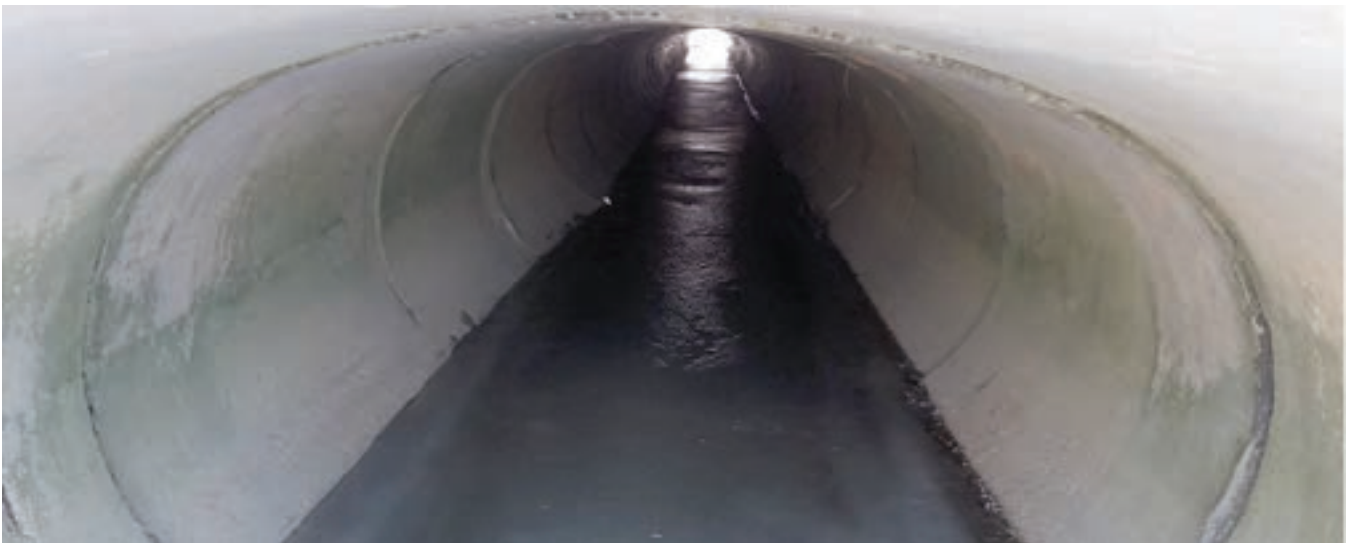
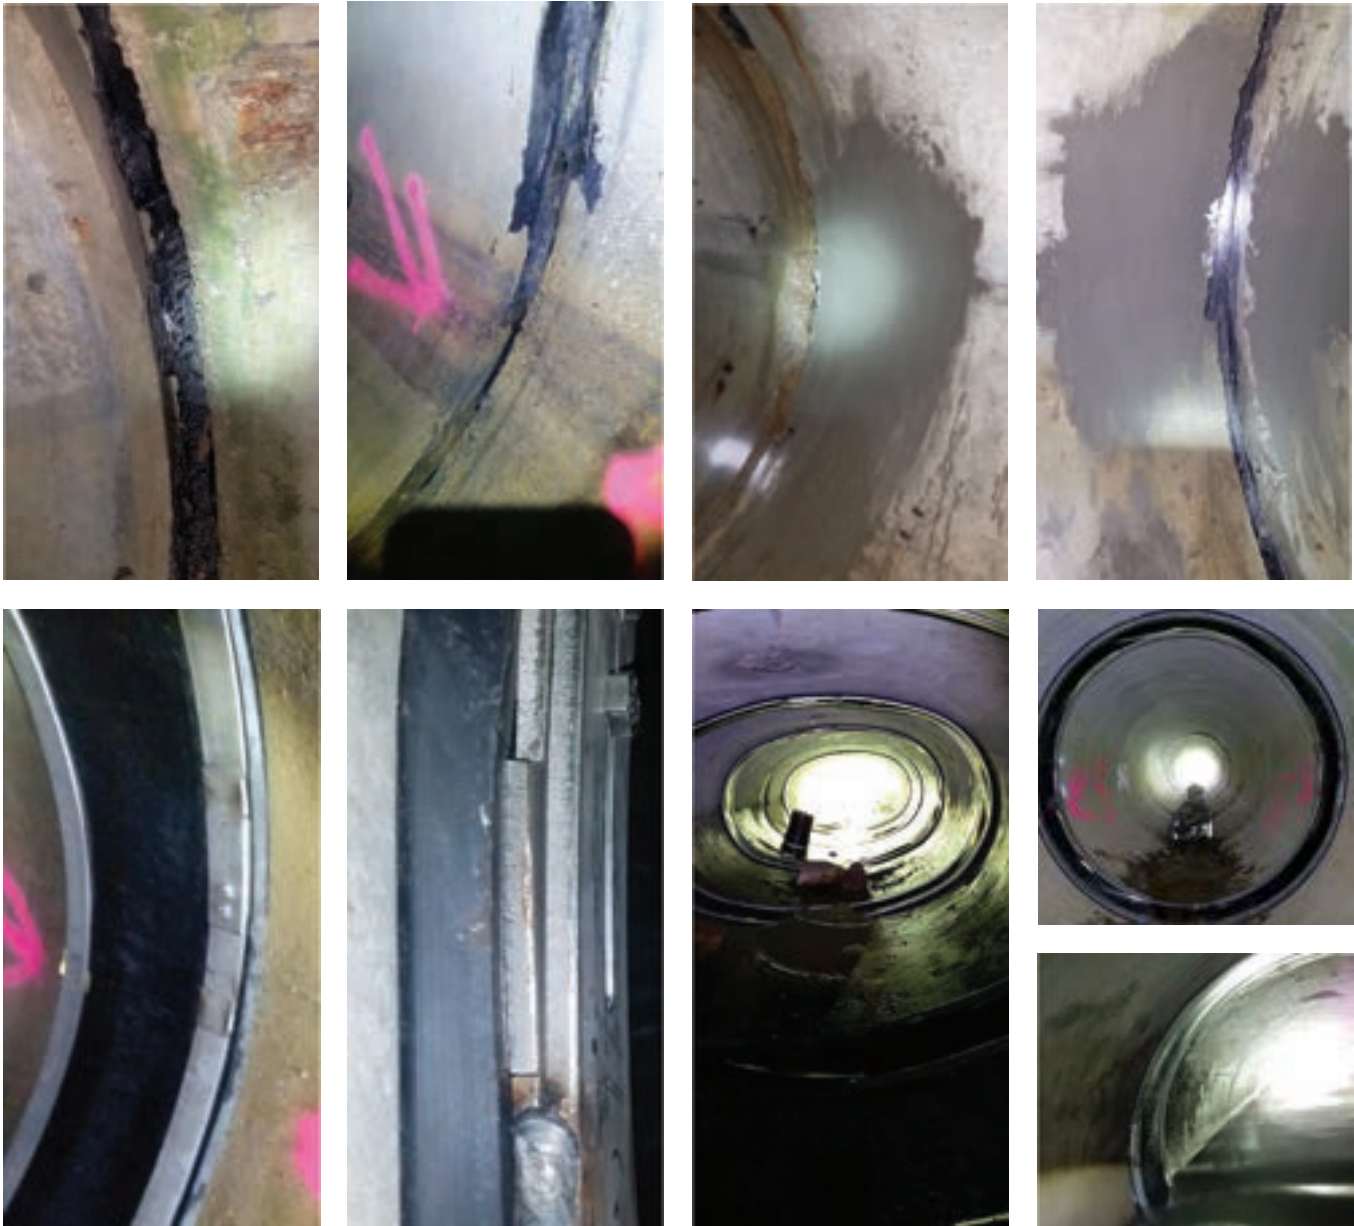
There were multiple sections of precast concrete culverts within ODOT District 7 that were showing signs of severe separation. The joint separation needed to be stopped so that the above roadways did not become damaged from infiltration/soil erosion.

Each pipe joint of concern was cleaned, smoothed with cement, and sealed with a HydraTite Internal Pipe Joint Seal. The installed HydraTite seals now prevent further separation of the existing pipe joints. This will help ensure infiltration does not cause soil loss under the existing roadways. The project was completed with minimal traffic disruption and at a fraction of the cost of other methods. This lifetime repair was successfully executed by HydraTech at 30 % below the engineer's estimate.
