INTERNAL PIPE

HydraTite®

JOINT SEAL

Market:
Stormwater

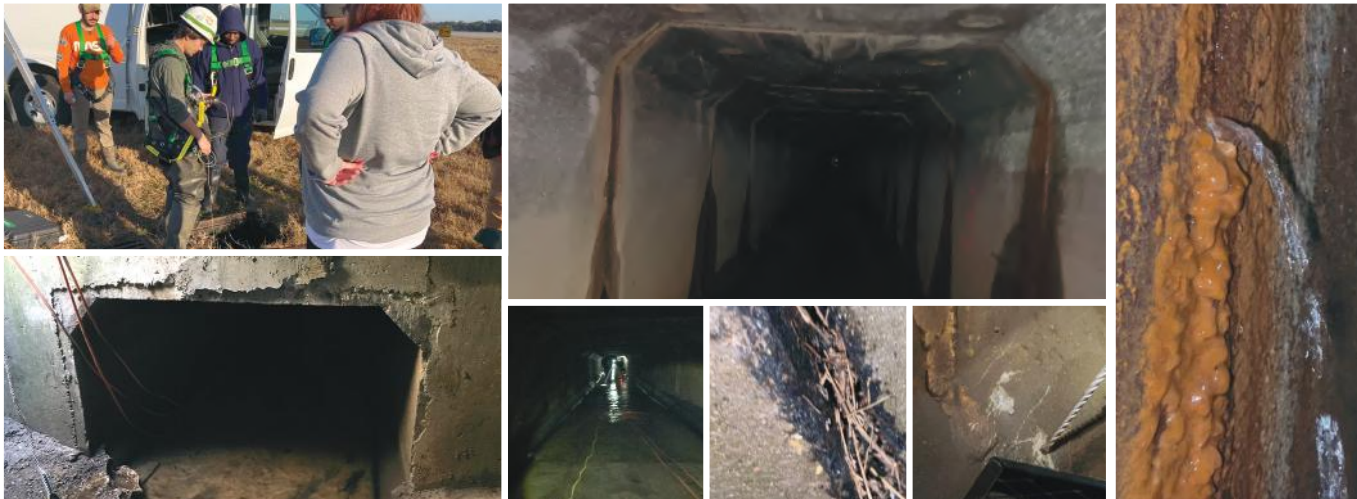
Leaks were discovered in three culverts that redirected stormwater below a runway at an airport in Mississippi. A 50 by 150-foot portion of the runway began to sink in due to erosion. The leaks were found in two culverts that were 6 by 6-foot and a third culvert that was 4 by 6-foot. Joints had minor separation which was allowing water, soil, and plant life to enter the pipe. The airport patched the runway and intended to continue operations during any attempted repairs.

HydraTech provided custom-made HydraTite seals with anchors and corner forms for all the joints in the three culverts. HydraTech also manufactured custom-made drill hole guides to speed up the anchor drilling.
