INTERNAL PIPE

HydraTite

JOINT SEAL

Power Plant

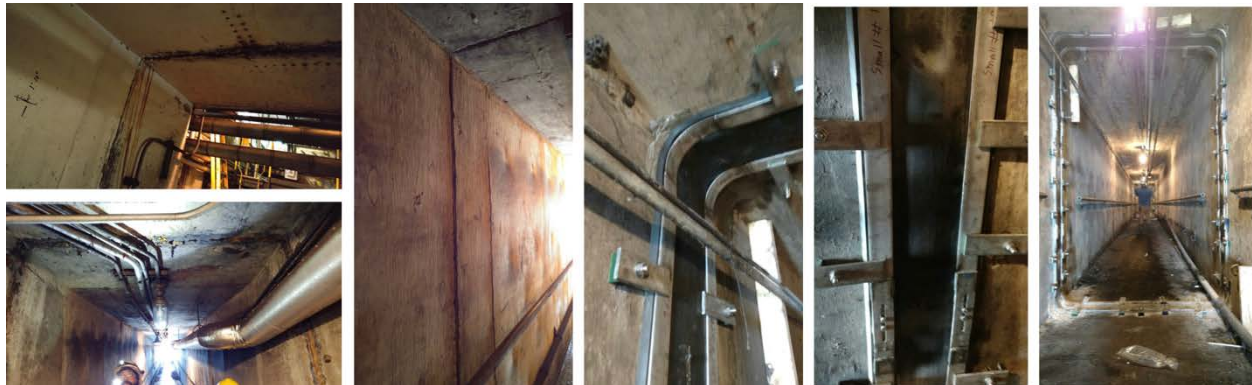
Groundwater was infiltrating a coal conveyor tunnel. The infiltration was at the joint of a concrete foundation in the tunnel. Damage from the water infiltration inside the tunnel was evident in the uneven settling of concrete sections. The water inside the tunnel also could damage equipment and was a slipping hazard for workers.

To eliminate the infiltration of water into the tunnel the HydraTite Box seal was proposed as a solution. The HydraTite Box seal is a customized mechanical remediation with no excavation required. The HydraTite Box seal flexibility accommodates ground settling and expansion/contraction. The seal's superior quality and intricate design assure a tight and leak-free seal.

Surface prep included moving conduits, relocating beams for the conveyor system, and removing grout ports. The existing joint surface had to be chipped and scraped to create a clean surface for a watertight install. Due to the slope of the tunnel, concrete corners were used instead of steel forms to allow the HydraTite seal to accommodate the 90-degree corners. The straight sections of the HydraTite seal are equipped with anchor clips.

Once the surface prep was completed 5 box seals were installed. One seal was in an active conveyor tunnel and one was in an inactive conveyor tunnel the other 3 were in an access tunnel. The Box seal for the active tunnel was installed during an outage, as it was a critical work item. The job was completed in approximately 3 week and eliminated all infiltration.
