INTERNAL PIPE

# HydraTite®

JOINT SEAL

During an inspection, Ohio Department of Transportation (ODOT) District 1 identified excessive joint separation within a 36-inch reinforced concrete pipe (RCP) beneath a roadway. One joint had also become offset, increasing the potential for infiltration and continued deterioration if left unaddressed.

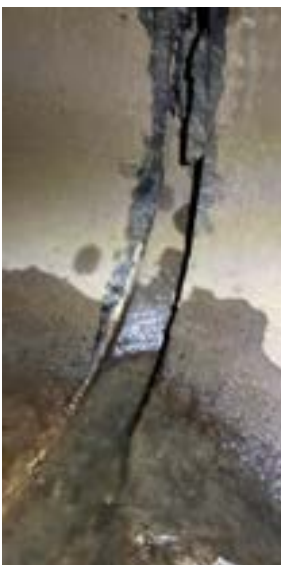
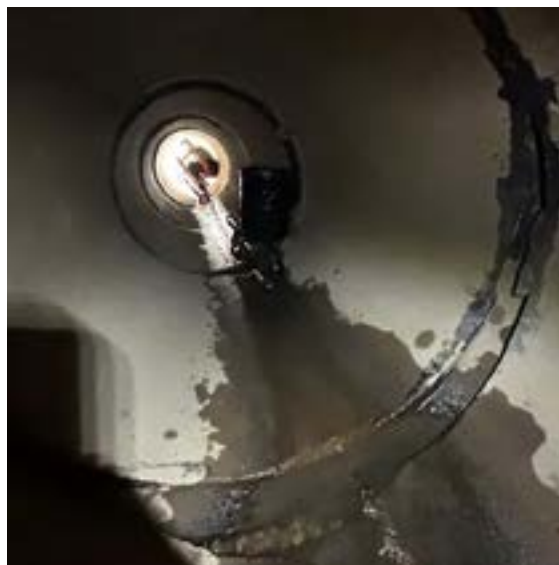
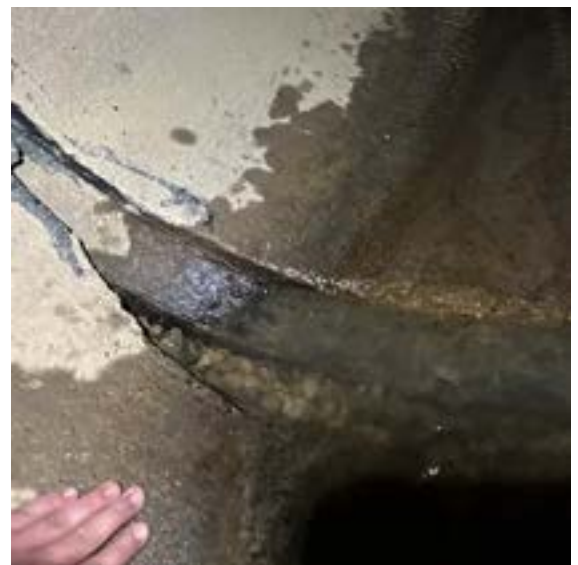
Although the pipe remained generally round, minor dimensional variations resulting from manufacturing tolerances and/or years of service meant it no longer measured perfectly in every direction. These slight irregularities are common in aging concrete pipe and require a sealing solution capable of conforming to the pipe's actual geometry while restoring a watertight joint.

The crew installed three HydraTite® Internal Pipe Joint Seals in the 36-inch reinforced concrete pipe, successfully rehabilitating the separated and offset joints. The entire installation was completed in approximately one and a half hours, demonstrating the speed and efficiency of trenchless internal pipe joint sealing. Throughout the repair, traffic continued uninterrupted above the pipeline, and no excavation or surface restoration was required.

All three joints were successfully rehabilitated, restoring the integrity of the pipeline and eliminating the concern created by the separated and offset joints. The project was completed with a two-person crew, minimal equipment, and virtually no surface preparation, allowing ODOT to quickly protect the pipeline without disrupting the traveling public.
